GREAT NEAPOLITAN EARTHQUAKE OF 1857.

OBSERVATIONAL SEISMOLOGY

TO INVESTIGATE THE CIRCUMSTANCES OF THE GREAT
EARTHQUAKE OF DECEMBER 1857.

ROBERT MALLET, C.E., F.R.S., F.G.S., M.R.I.A.,
&c., &c.

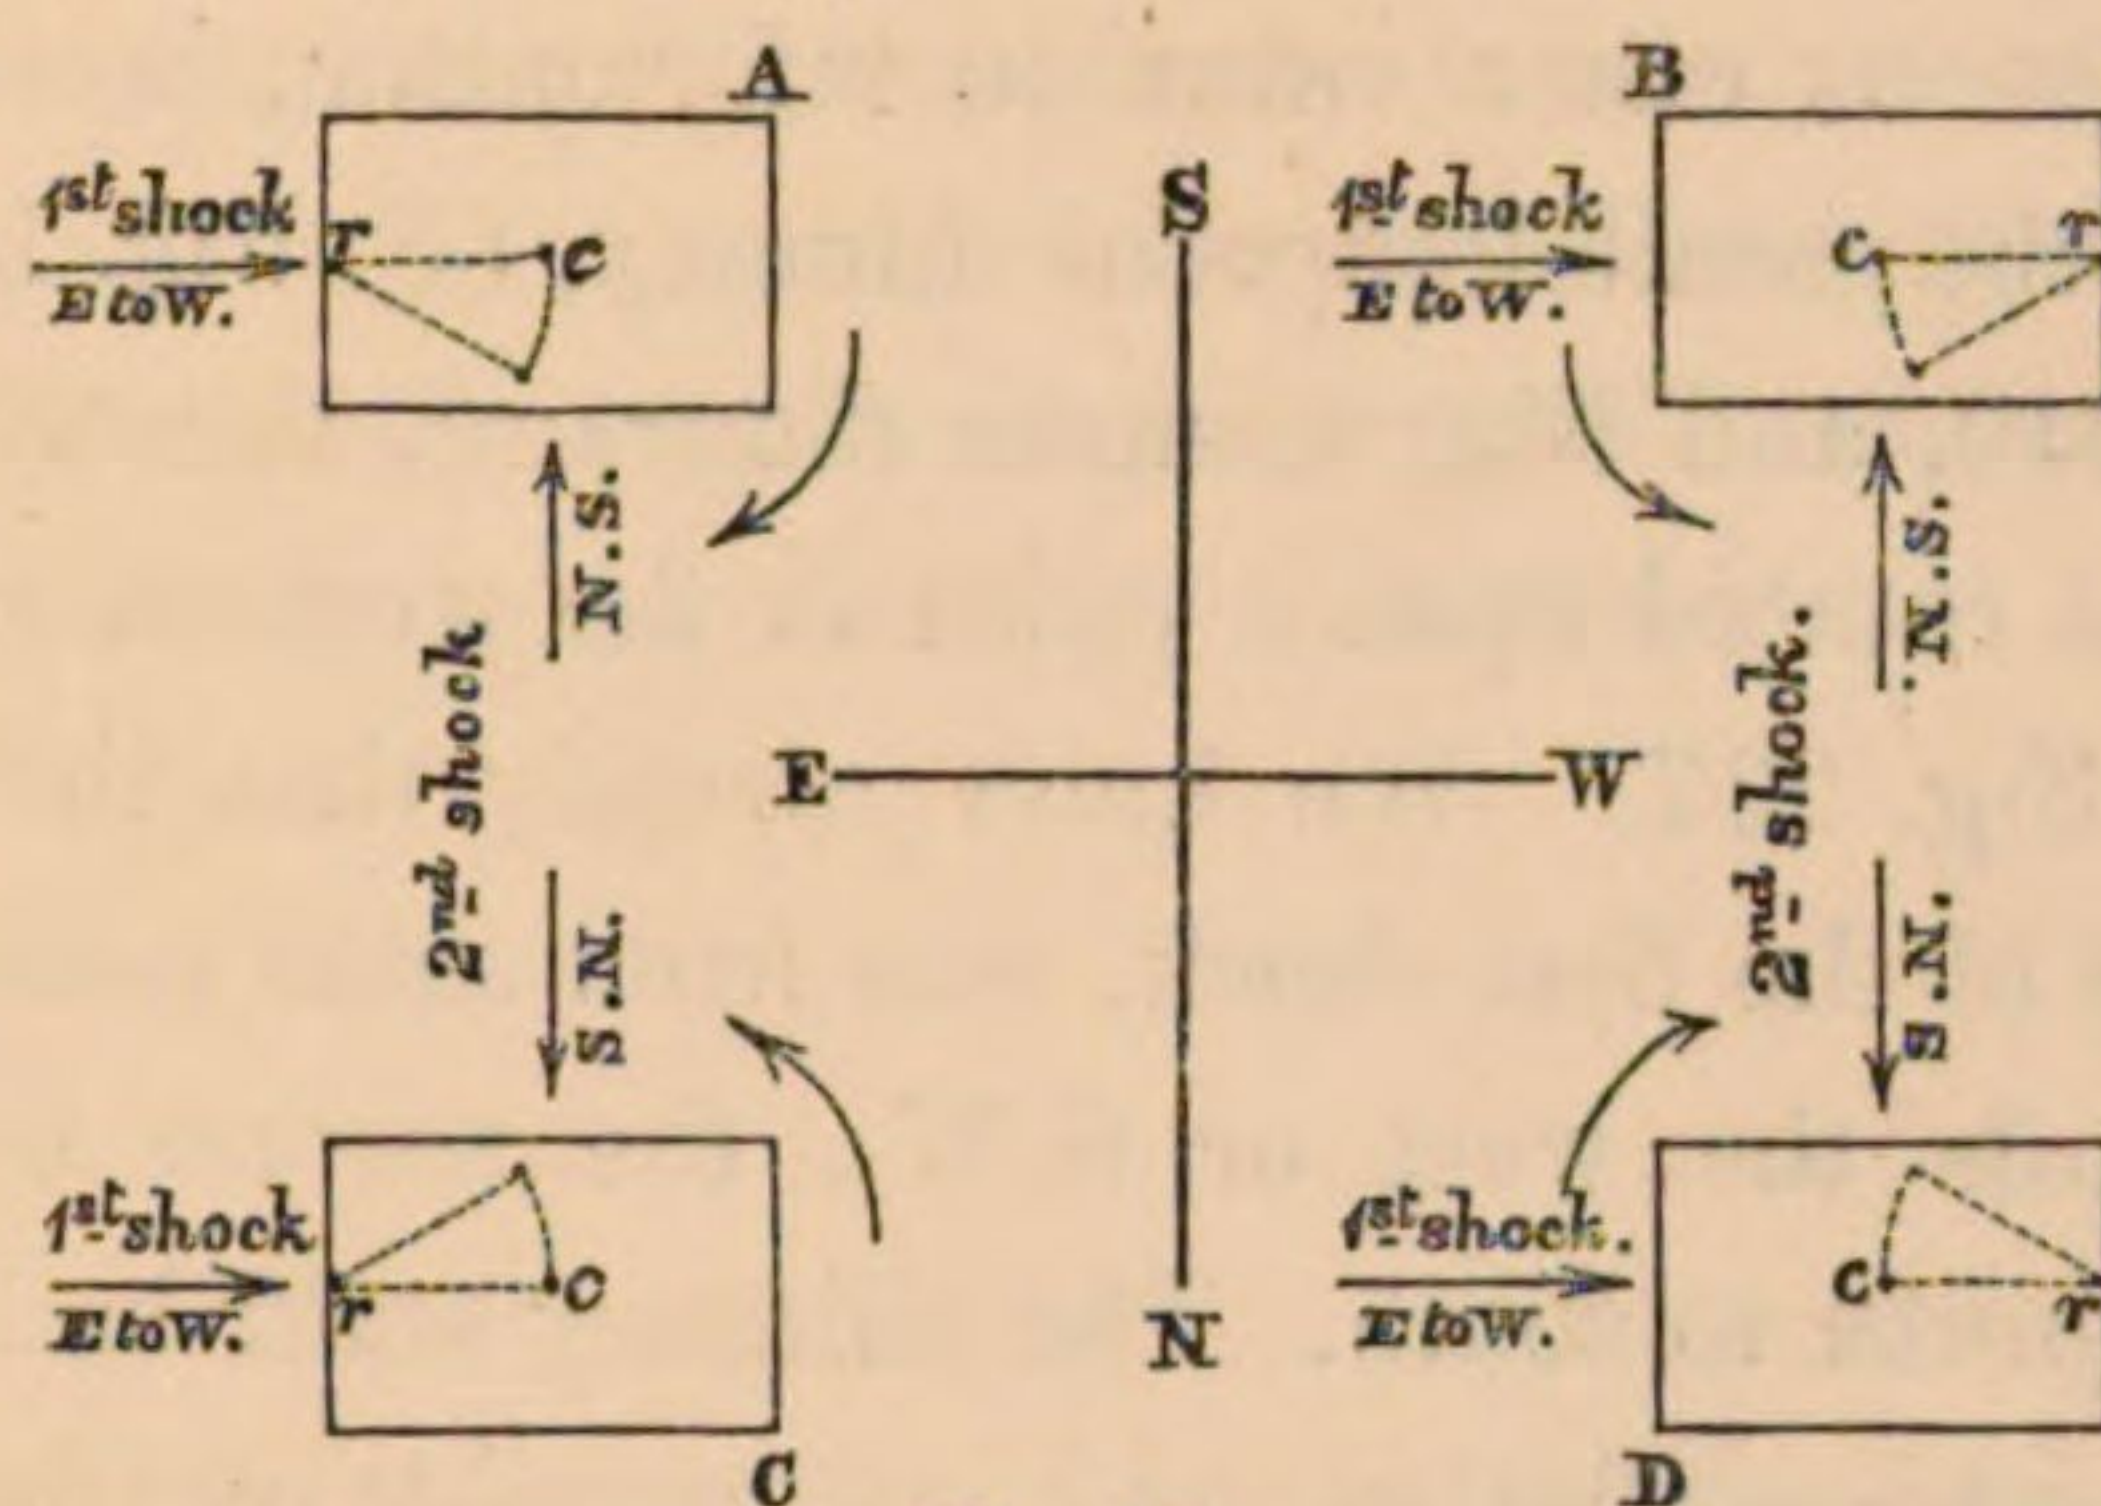
Fig. 236.

semiphase A, and second semiphase B, by the same double shock; secondly, the like by rotation, in the first semiphase (C), the first shock being as before, but the second, contrary in direction to that of the previous cases (A and B), and the like for the second semiphase (D), the two shocks being the same (C and D).

Applying this to the facts at the monument of St. Bruno. All the finials, &c., are twisted from left to right; we know that the main shock was from 15° W. of north to the south, it therefore follows, that the shock which first moved them, arrived in a path somewhere between that, and from east to west: by this they were *tilted*; by the immediately following shock, 15° W. of north to south they were *twisted*. Neither shock was sufficient, in velocity or range, completely to overthrow any of them, except those which were top-heavy, by having had balls at their summits, which have, except in one instance, been all dislodged.

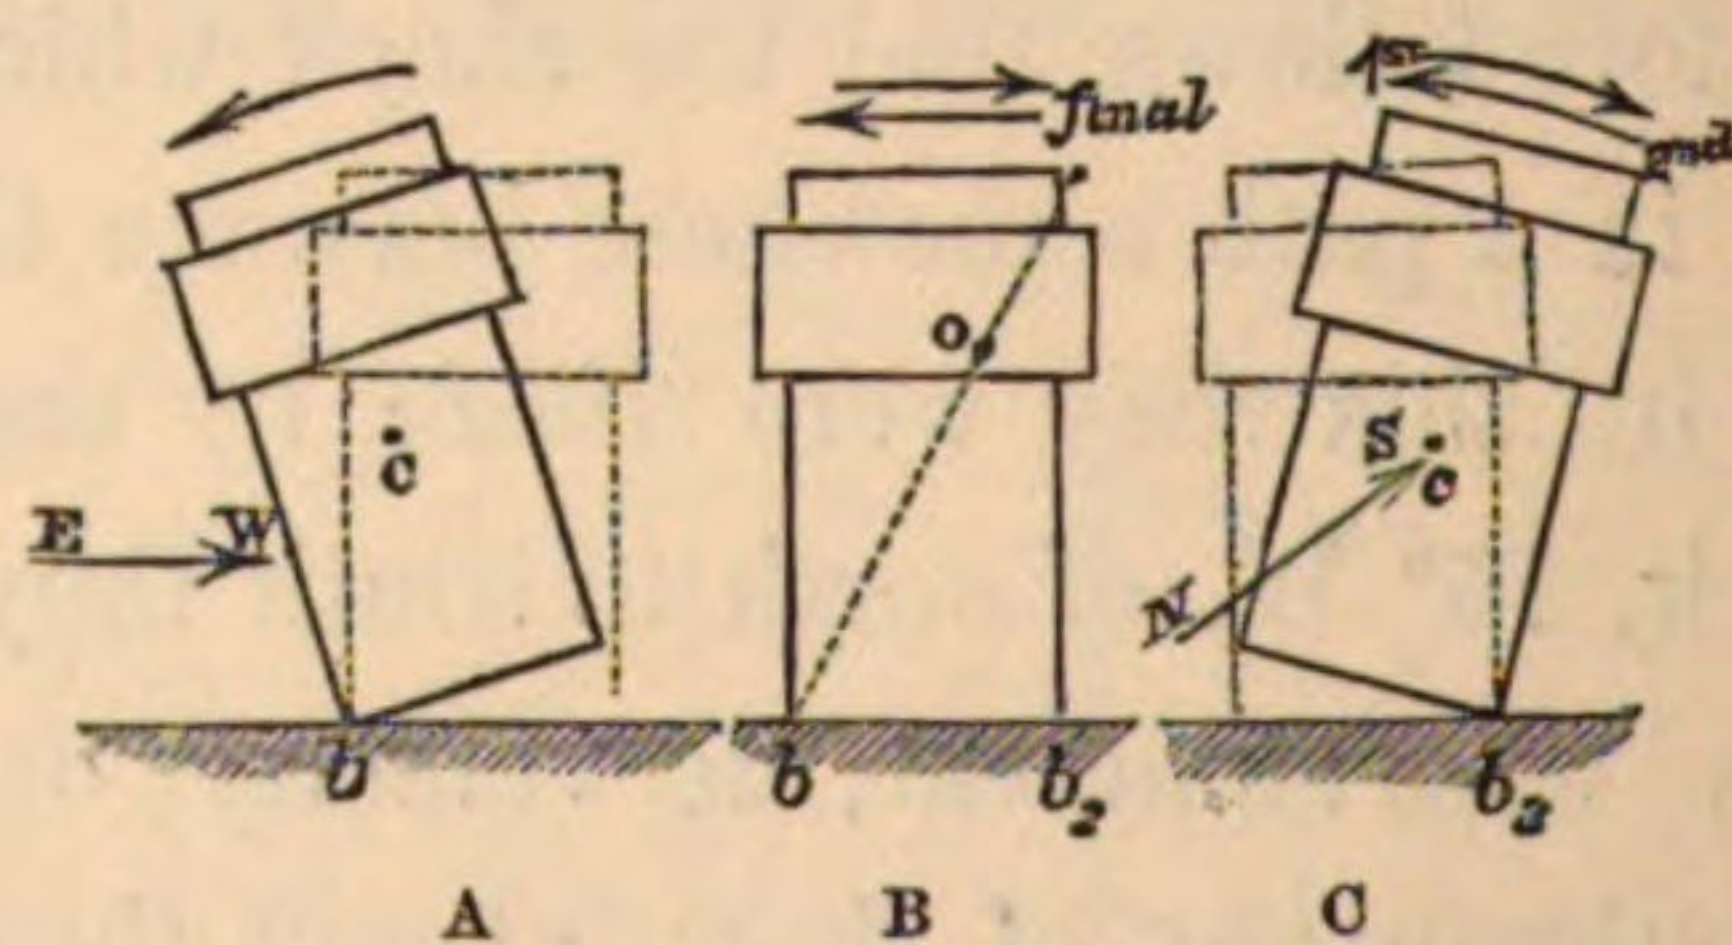
They give us other valuable information, however. In the case of the parallelopipedal chimney, (F. Fig. 1, Diagram Nos. 238-240, and Fig. 4, same diagram), twisted upon its base, it had rotated upon a point in the western edge of its base at b , Fig. 237. We know already that the direction (generally) of the first shock, was from some points east or N.E. towards the west or S.W., the second being from 15° W. of north to south. The chimney stalk had therefore made, *one semi-oscillation*, and *one complete oscillation*; that is, it was being acted on by the *second* semiphase of the wave of the *first* shock, at the moment when the second shock arrived at it, as in Fig. 237.

The centre of oscillation of the chimney above b thus tilted was, as nearly as could be ascertained, 4.33 feet distant from the edges of the base upon which it tilted b and b_2 . The first shock, east to west, fractured the chimney from its base, and produced in the detached chimney, one semi-oscillation eastward (A, Fig. 237). The chimney then

relapsed upon its base (B), Fig. 237, and rising again upon the edge b_2 , leaned over westward (C), Fig. 237, having thus made one complete oscillation in that direction, with the moment of repose (B), when it had fallen back plumb upon its base. Between that moment of repose, and the completion of the oscillation, or *almost instantly after it had commenced to fall back* (C) from west to east, to reassume its original position of repose, the second shock from the north to south reached it, and twisted it round horizontally, in the manner that has been already explained.

The chimney may be regarded as a parallelopiped vibrating as a compound pendulum, upon b , and b_2 (Fig. 237) as points of suspension, whose centre of oscillation is in the plane of shock passing through the centre of gravity, and distant from b or b_2 by two-thirds of the diagonal of the parallelopiped, in the same plane.

This distance = 4.33 feet is the length of the corresponding simple pendulum, with some small allowances for the hollowness and irregularity of form. The greatest possible arc of vibration, is limited by that which would bring the centre of gravity, c , vertically over b and b_2 , Fig. 237, beyond which the mass must have fallen. This I found to be 21° , at either side of the vertical through the centre of gravity, when the chimney was in its original undisturbed state.

From the moment of arrival of the first shock, up to the arrival of the second transverse to it, the chimney had made, one half and one complete, vibration, and possibly had just commenced another. At the moment that the chimney relapsed upon its base it lost *vis vivâ*, and therefore *time*, before it rose again, to complete the arc westward. This minute loss of time we can only estimate, because although we know the velocity at the moment the mass of the chimney struck its base, on resuming the perpendicular (B, Fig. 237), we do not know its hardness, elasticity, &c., upon which that loss also depends.

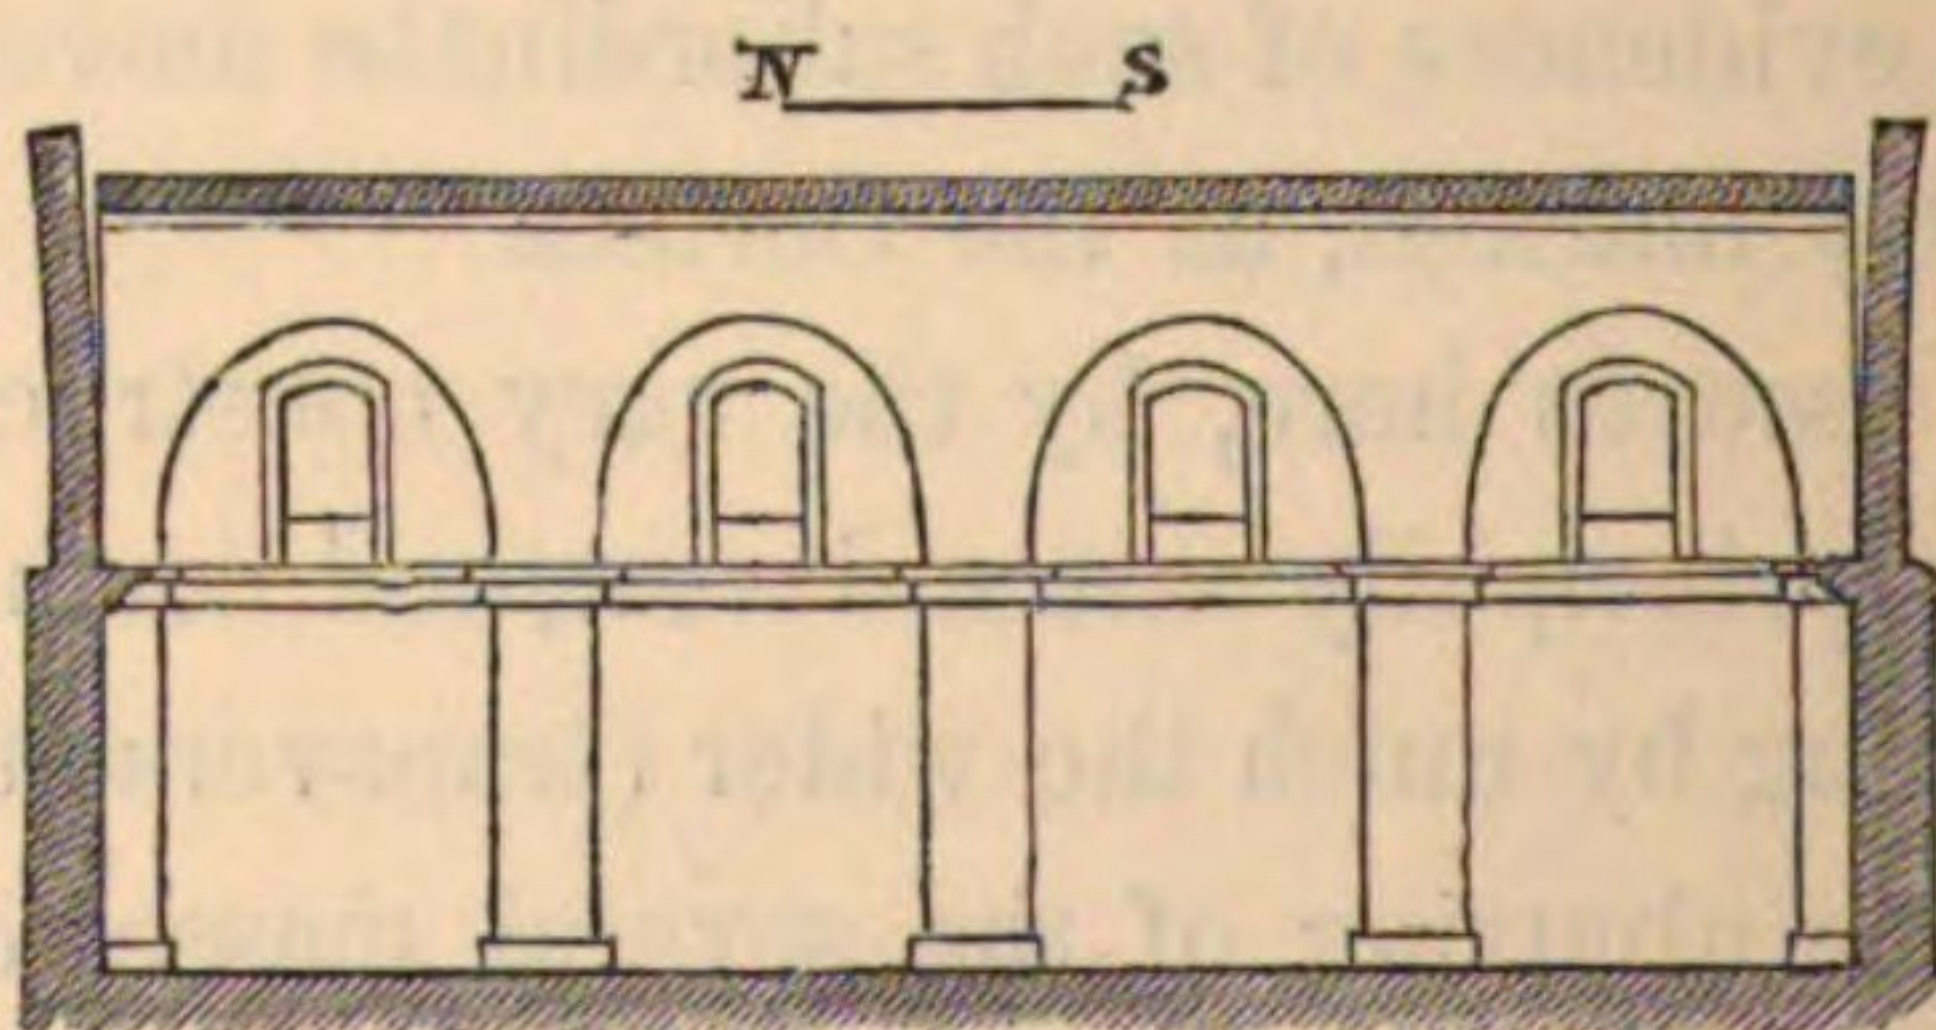
Fig. 239.

To the eastward of the front square, the roofs of the church, and of the grand refectory, groined and arched buildings of great magnitude, have been heavily fissured. In the refectory both end gables, (Fig. 239,) run up originally against the ends of the brick vault, have parted off from it, and pre-

The gables were great semicircular walls of rubble stonework, run up from the chord-line or level of the springing, after the vault had been turned, and merely closed in against the ends of the arch, as in Fig. 239, not being bonded into it. Each of these gable walls had gone out at top from the end of the vault, producing a gradually widening and tremendous fissure, which, at the north end, was open 5 inches at top, and at the opposite, or south end, 3 to $3\frac{1}{2}$ inches.

The gables, thick, heavy, inelastic, and yielding, from the bad rubble of which they are built, had bent over from above the chord-lines, showing innumerable minor thread-like fissures of dislocation in the work, more or less horizontal; neither had approached within some inches of the

limit of stability. The north gable wall had given out in the first semiphase of the shock, the south in the second semiphase ; and both appeared, from the fragments fallen into the fissures, none of which were crushed, or gripped and pressed into compacted powder, (as is not unusually the case,) to have gone out very little, if at all further, by the impressed movement, than where they stood as I examined them.

The width of this north fissure, therefore, affords an approximate measure, of the actual amplitude of the main wave of shock here ; for the opening, or the actual movement of the gable, at the level of its centre of oscillation, upon the chord as axis, must have been about equal to the amplitude of the wave, taken in a horizontal line. It would be useless, upon inexact data, to pursue this minutely ; we may conclude, however, that the horizontal amplitude of the main wave of shock here, did not much exceed 4 inches.

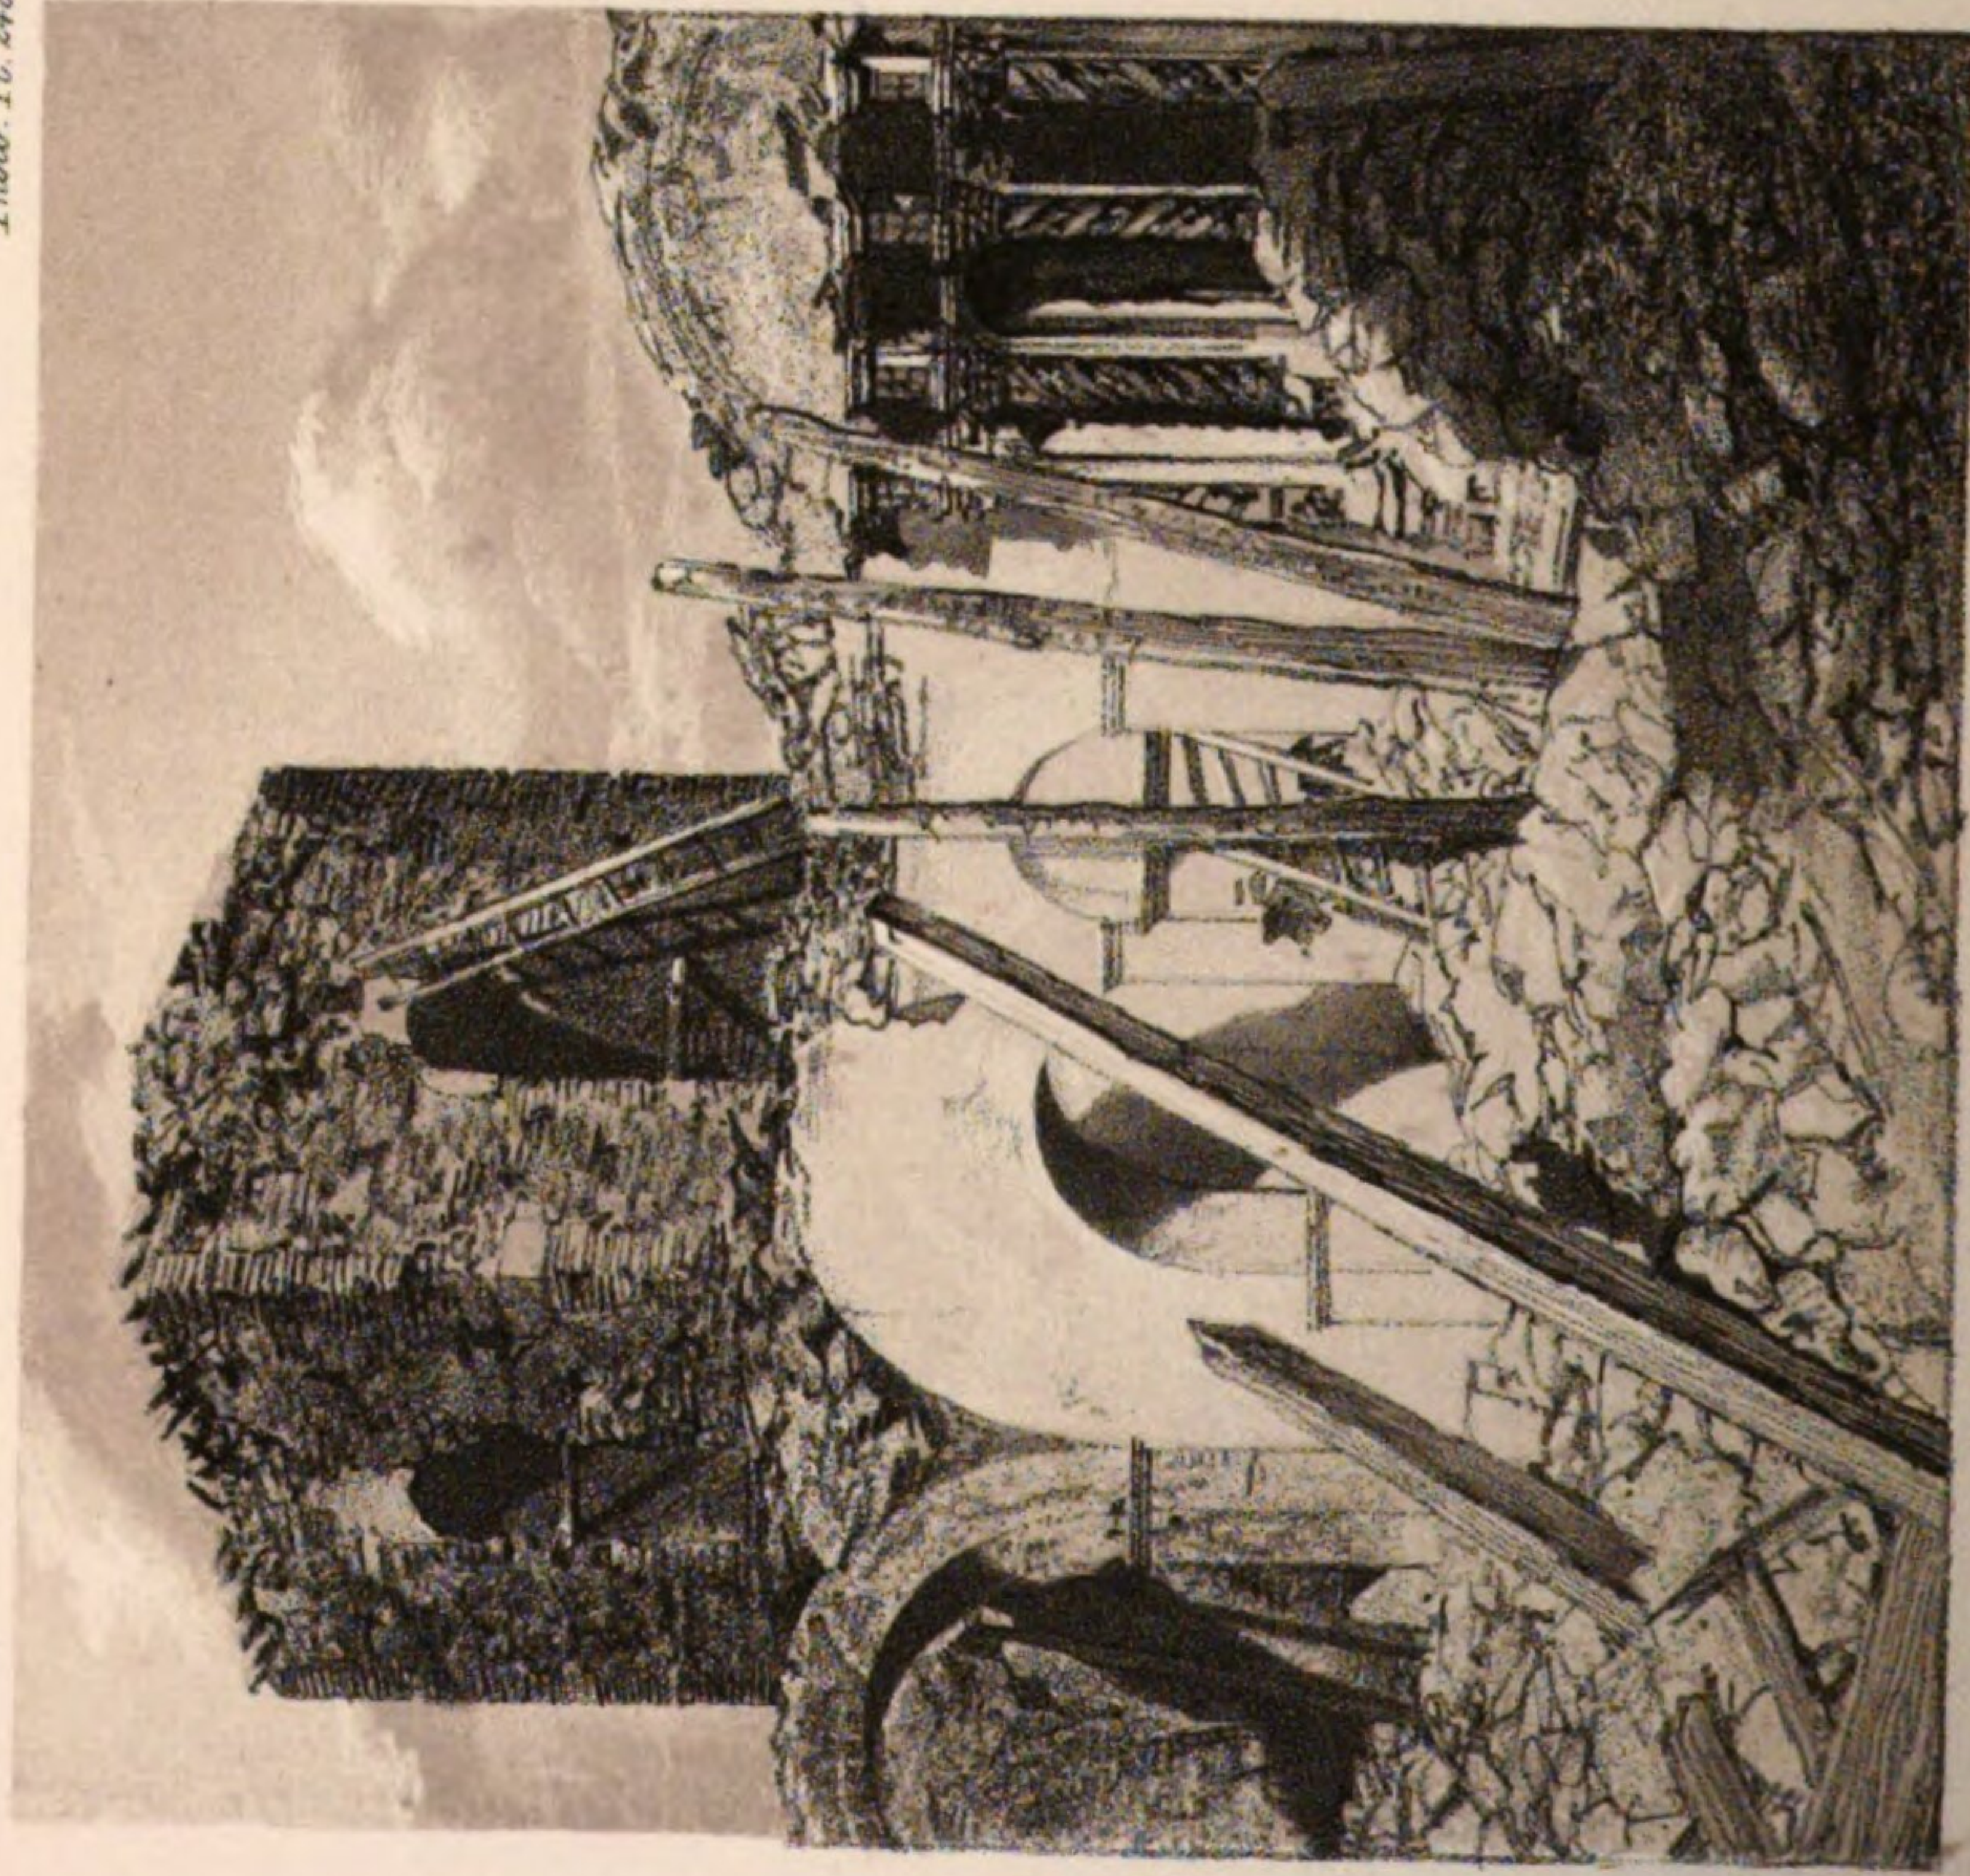
Photo. Pl. 248.

SARCONI.
Remains of the Church.

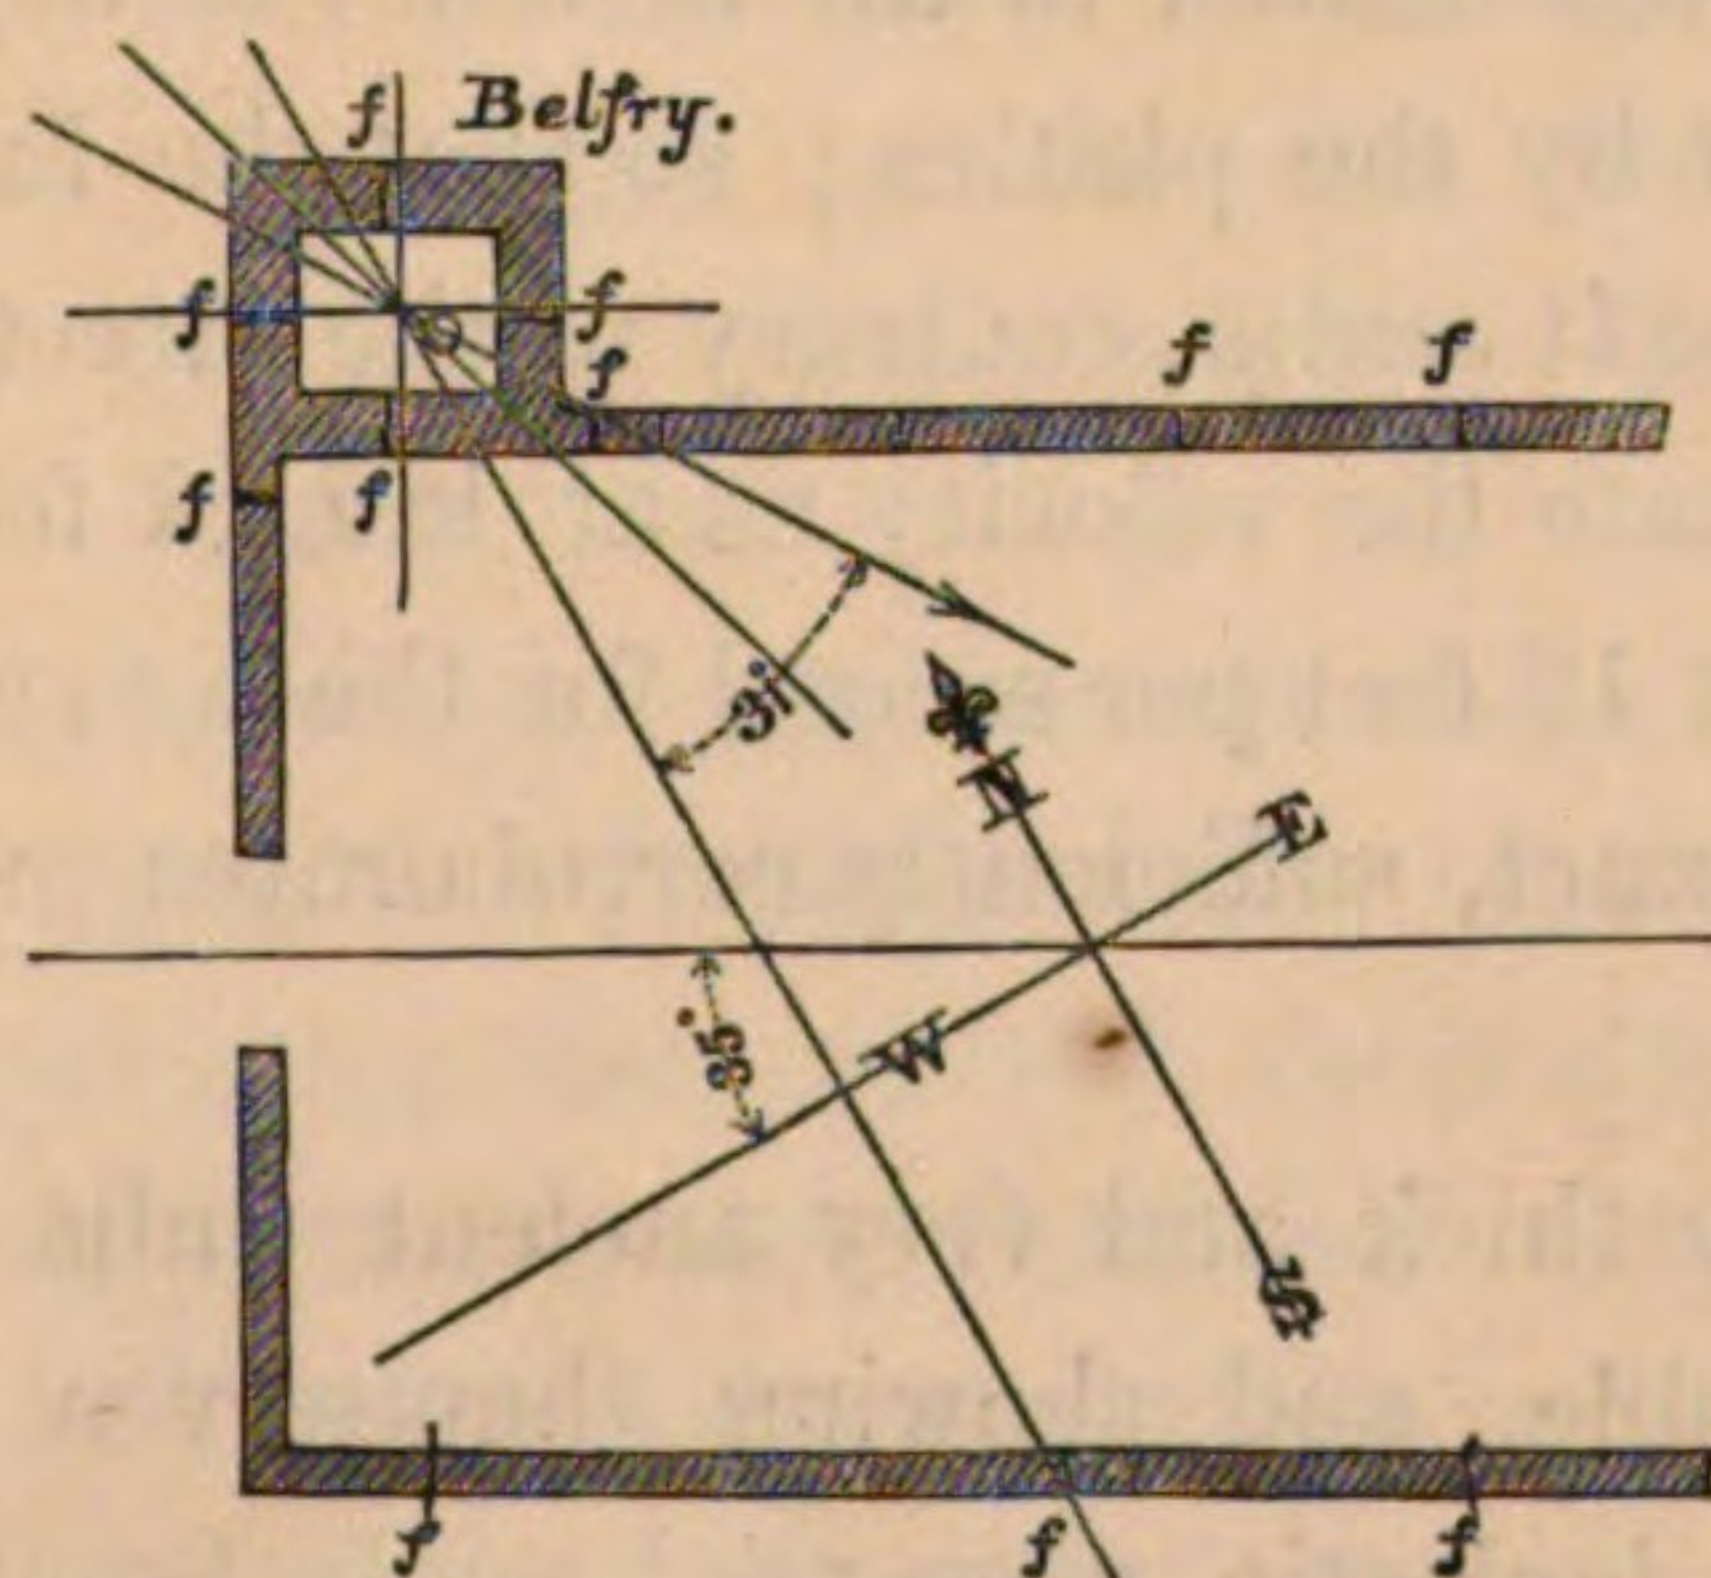
Fig. 250.

The old church, however, gave better results. It was a building of great antiquity; the axial line was 55° W. of north, and, on entering the western door, I observed that two ancient and probably Roman altars, with nearly effaced inscriptions, had been built into the walls, and formed the pedestals for the stone jambs of the doorway. The building has wholly fallen in, and in great part the walls are down. The belfry tower stood at the north quoin (Photog. No. 248), a tower, of about 20 feet square, of which about 47 feet in height remain standing. The whole of the upper part has been thrown down, and the mass has fallen, partly within and partly without the church, and some on the highest remaining floor of the tower itself, all falling towards the S.E. There was a single bell in the tower, of about six cwt., which hung, as the "Parrochiano" (an aged priest, who politely came out in the rain to give me information, and whose name, I regret to find, I omitted to note) informed me, to a beam in the centre of the tower, and at

timbers, with its mouth facing S.E. The centre of gravity of the bell, was 7 feet horizontally, distant from the centre of the tower, and the direction of its throw from the centre of the tower was 149° E. of north (Fig. No. 250).

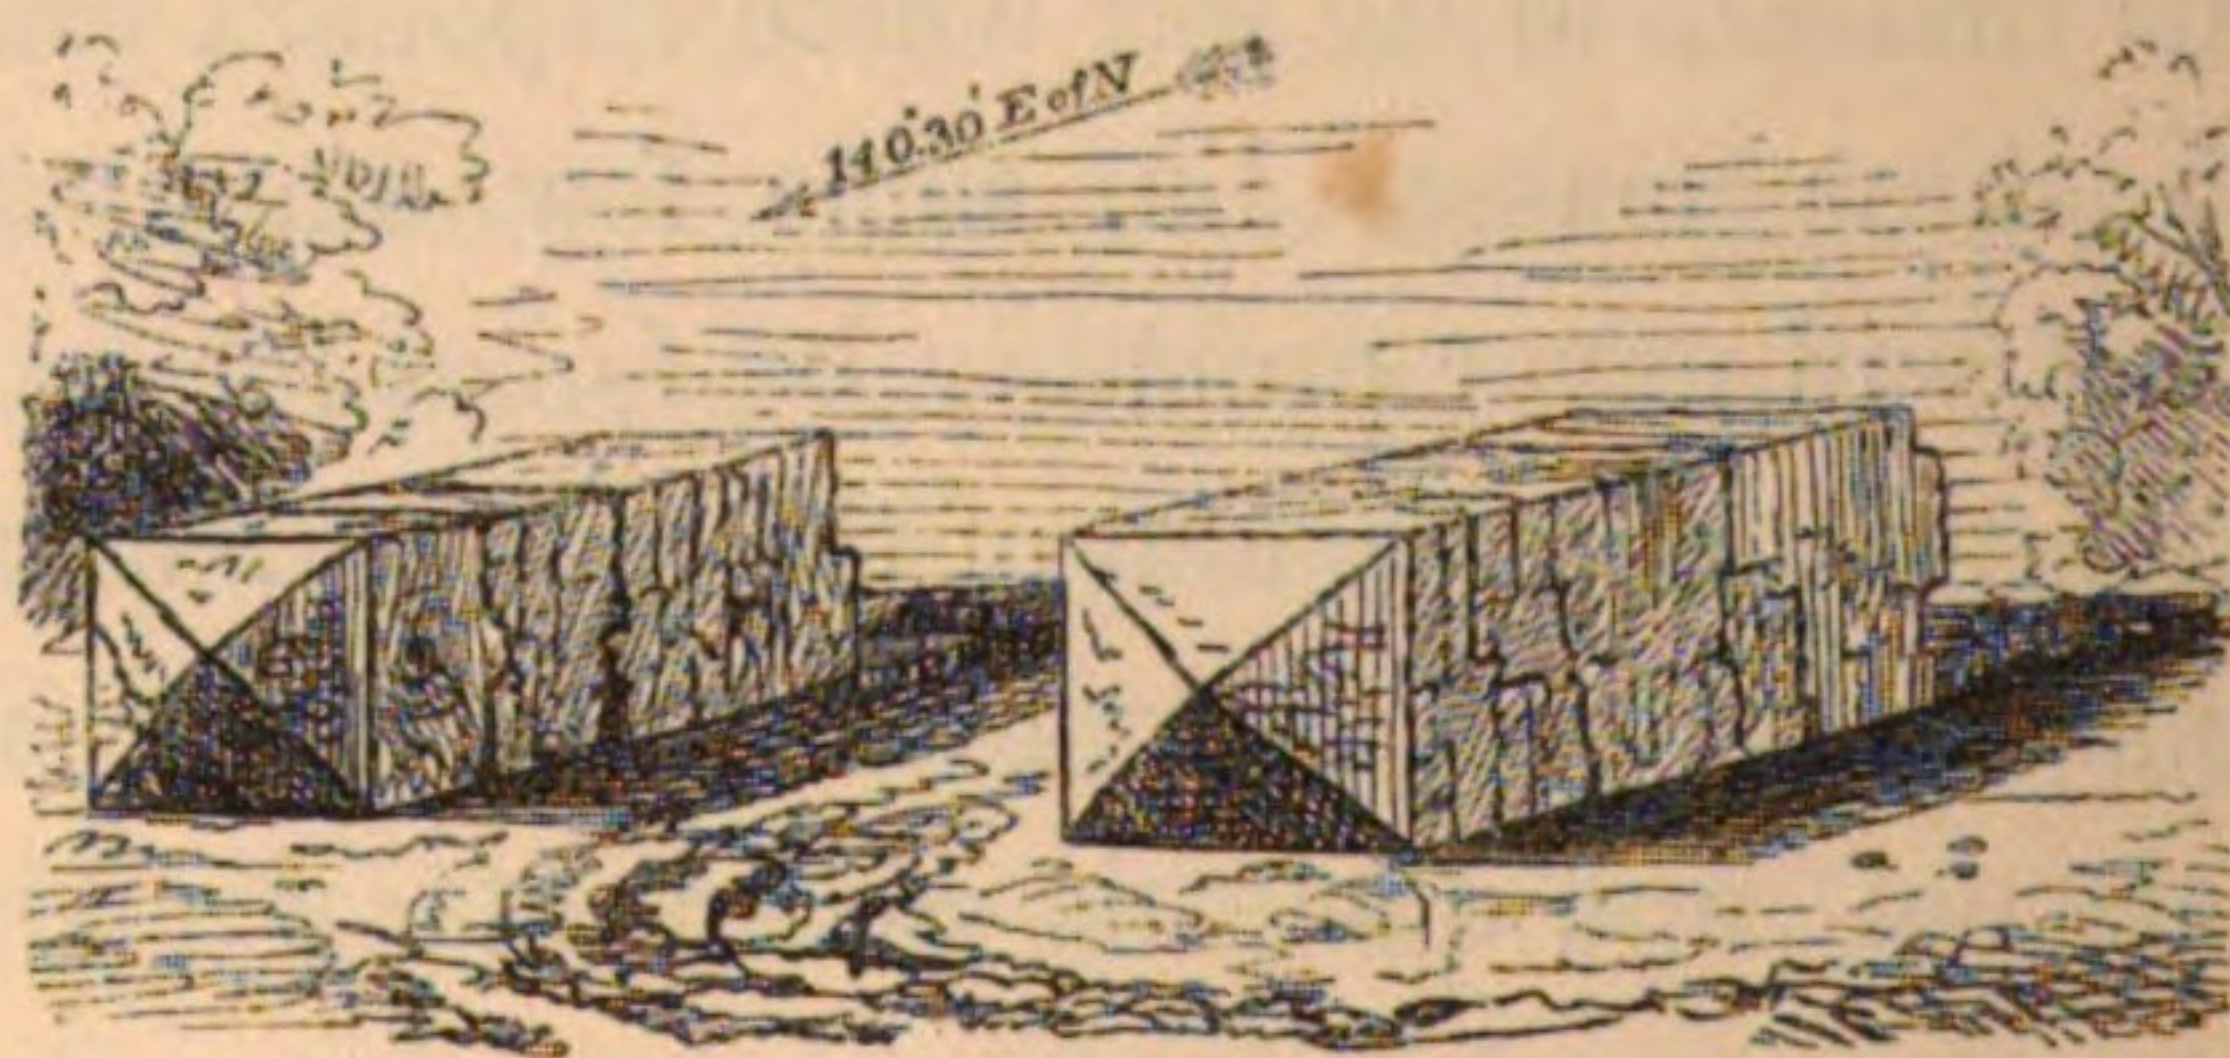
Fig. 257.

About half a mile S.E. of Saponara, upon the level clays of the piano, I passed two square gate-piers of rubble ashlar masonry, leading to an orchard, 3 feet square, and 7 feet in height, both prostrated, and in directions accurately parallel, $140^{\circ} 30'$ E. of north, fractured at the ground level from their foundations. The mortar was bad, and by examination with the hand I judged had not an adhesion

of more than about 2 lbs. per square inch. The wave-path was exactly subnormal to the piers (Fig. 257).
